AD A 053899

4. TIT	LE (and Subtitle)			-	5. TYPE OF REPORT & PERIOD COVERE
	ponent Dan se (EMP) I			omagnetic 9	Technical Memorate
Pul	se (EMP) 1	induced Ti	ransien	ts.	6. PERFORMING ORG. REPORT NUMBER

7. AUT	HOR(e)				B. CONTRACT OR GRANT NUMBER(*)
Jos	eph R./Mil	letta			DA. 1W062118AD51
	FORMING ORGANI				10. PROGRAM ELEMENT, PROJECT, TASK AREA & WORK UNIT NUMBERS
	ry Diamond O Powder M		ories	•	Program Ele: 62118A
	lphi, MD				
	TROLLING OFFI			. (1	12. REPORT DATE
	Army Mater adiness Co		copment	and L	October 1977
21	xandria, V				13. NUMBER OF PAGES
			ESS(II dillere	nt from Controlling Office	SECURITY CLASS. (of this report)
					UNCLASSIFIED
					15a. DECLASSIFICATION/DOWNGRADING

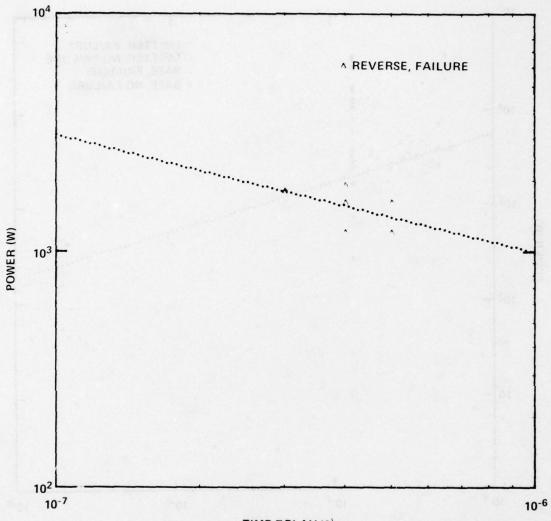
The test data for the RAY transistor are presented in figure 72; those for the FSC transistor, in figure 73. Both RAY and FSC

Figure 72. Damage line, power, E-B, Raytheon 2N2297 transistor.

transistors experienced apparent thermal second-breakdown failure as ascertained by the voltage and current oscillograms. As the data indicate, there was a considerable spread about the least-squares-fit damage line for the FSC transistor, while the RAY transistor data closely adhered to the model. There is no explanation for the spread on the FSC data. The least-squares-fit damage lines for both RAY and FSC data appear to be about a factor of two different in threshold level, the RAY transistor being the "harder."

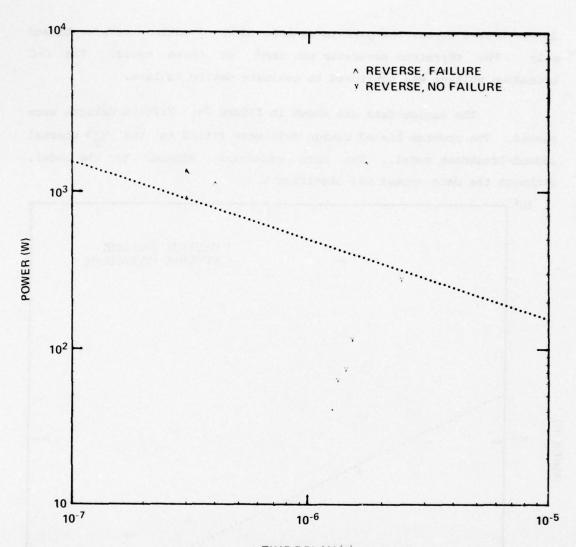
TIME DELAY(s)
Figure 73. Damage line, power, E-B, Fairchild 2N2297 transistor.

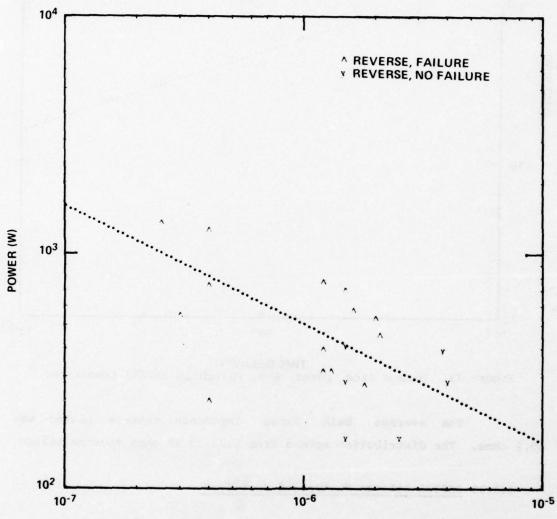
The damage data are shown in figure 74. Fifteen devices were tested. The reverse-biased damage data were fitted to the $T_D^{-\frac{1}{2}}$ thermal second-breakdown model. The data reasonably adhered to the model, although the data spread was significant.

TIME DELAY(s)
Figure 74. Damage line, power, G-C, General Electric 2N2323 rectifier.

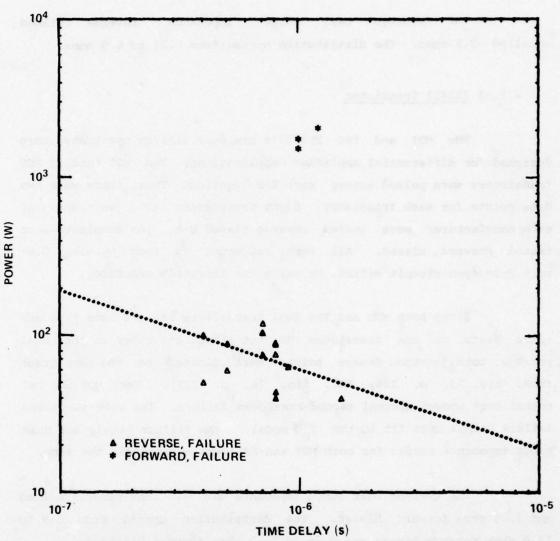
Since both MOT and FSC dual transistors are the same type and since tests on one transistor do not affect the other in the dual package, both junction damage points were plotted on the same graph (MOT, fig. 75, p. 124; FSC, fig. 76, p. 125). Both MOT and FSC transistors showed thermal second-breakdown failure. The reverse-biased failure points were fit to the T_D^{-1} model. The failure levels and bulk surge impedance ranges for both MOT and FSC were essentially the same.

Figure 75. Damage line, power, E-B₁/B₂, Motorola 2N2453 transistor.

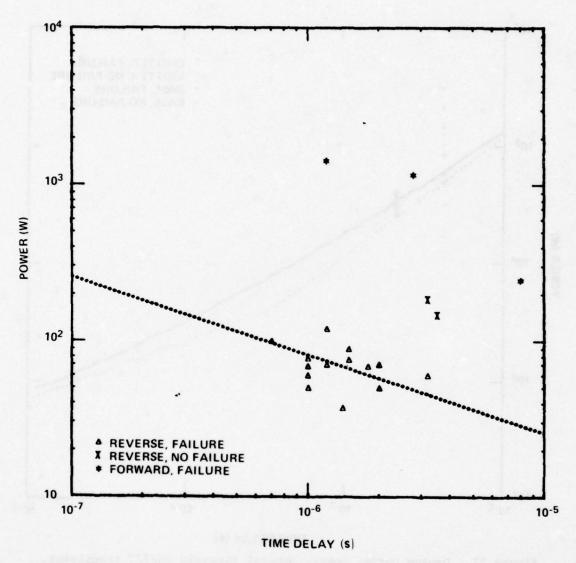
Figure 76. Damage line, power, $E-B_1/B_2$, Fairchild 2N2453 transistor.

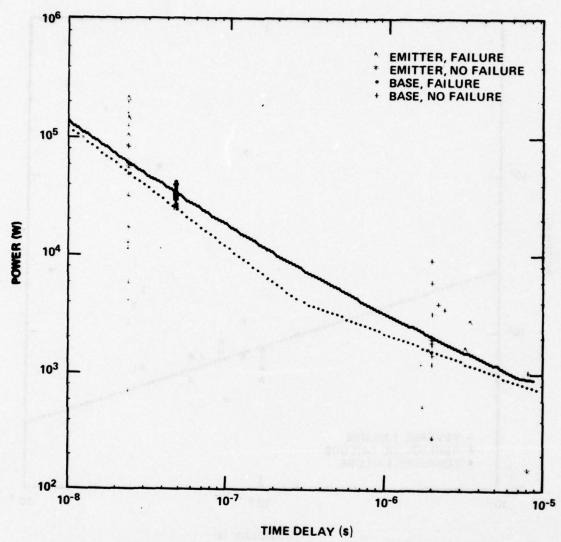
The damage data are shown in figure 77. The voltage and current oscillograms indicated a thermal second-breakdown failure for the junction reverse biased. The junction was pulsed forward biased, and the required voltage for failure forward biased was more than twice that reverse biased. The current levels through the transistor forward biased exceeded 100 A. At these current levels, the available current probes saturated, so it was useless to carry some of the tests to the damage point.

The average bulk surge impedance equalled ~1.2 ohms reverse biased and ~1.0 ohm forward biased. The distribution spread from 0.8 to 1.8 ohms reverse biased and 0.3 to 2.4 ohms forward biased. For the 24-ns pulse, the reverse-biased bulk surge impedance was 4.2 ohms with an associated spread of 2.3 to 6.1 ohms. The sample size was 19.

Figure 77. Damage curve, power, General Electric 2N2727 transistor.

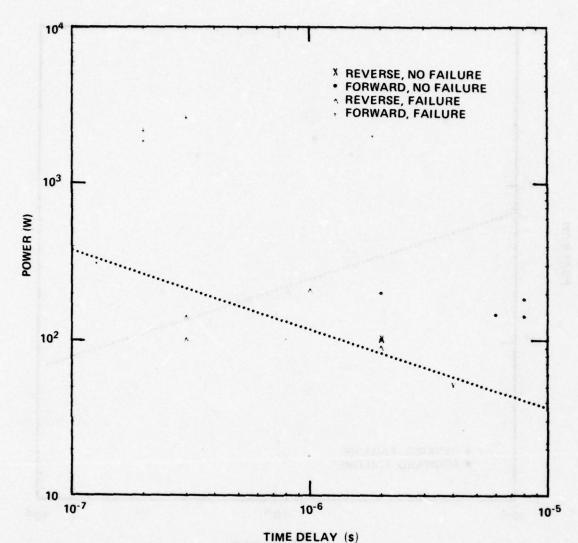
Figure 78. Damage line, power, E-B, Fairchild 2N2801 transistor.

The transistor shows a thermal second-breakdown failure mechanism in the voltage and current oscillograms. The data of both FSC and MOT transistors show fair correlation to the $\mathbf{T}_D^{-\frac{1}{2}}$ thermal model. The least-squares-fit damage lines are within a factor of two of each other. The MOT transistor appears slightly "harder." However, the sample sizes are too small and the data are spread too much for a conclusion.

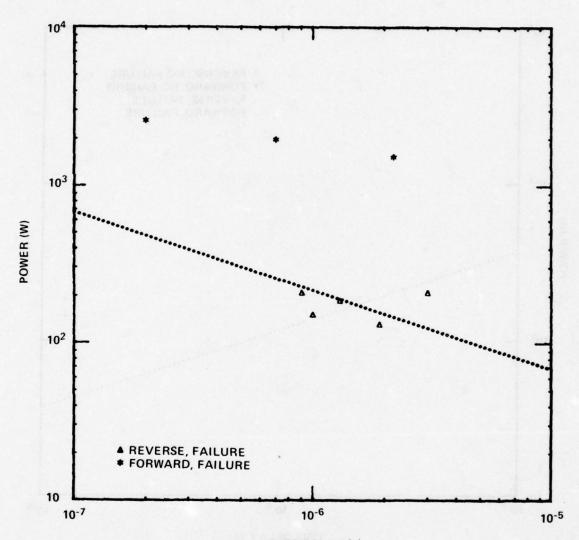
TIME DELAY(s)
Figure 79. Damage line, power, E-B, Motorola 2N2801 transistor.

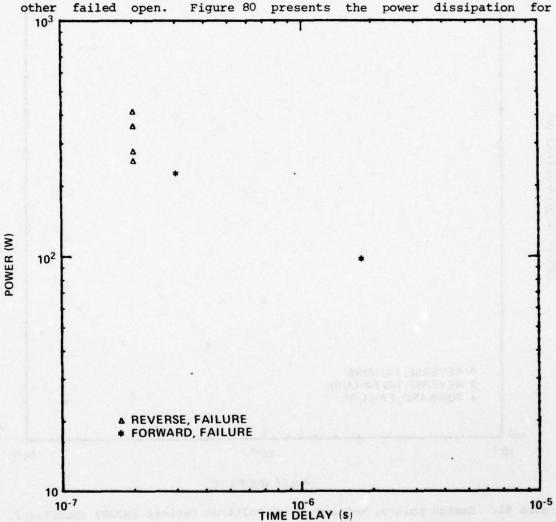
Postdamage electrical tests indicated lead or metalization failure resulting in apparent junction open circuits. The measurements did not indicate a thermal second-breakdown response. Two transistors were pulsed forward biased; one degraded as a short circuit and the other failed open. Figure 80 presents the power dissipation for

Figure 80. Damage points, power, G-D, Solitron Devices 2N3069 transistor.

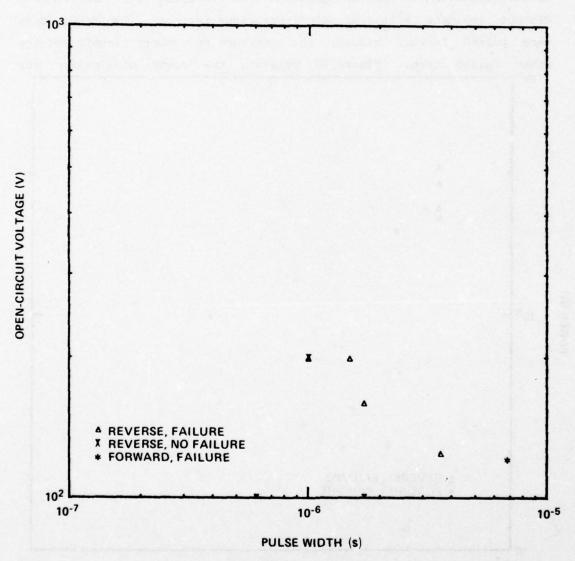
failure. The data have not been fitted to the thermal models. The results of figure 81 indicate that a voltage threshold of $\sim 100 \text{ V}$ might be a better criterion for failure. The bulk surge impedance was impossible to calculate, the values being extremely high.

Figure 81. Damage points, voltage, G-D, Solitron Devices 2N3069 transistor.

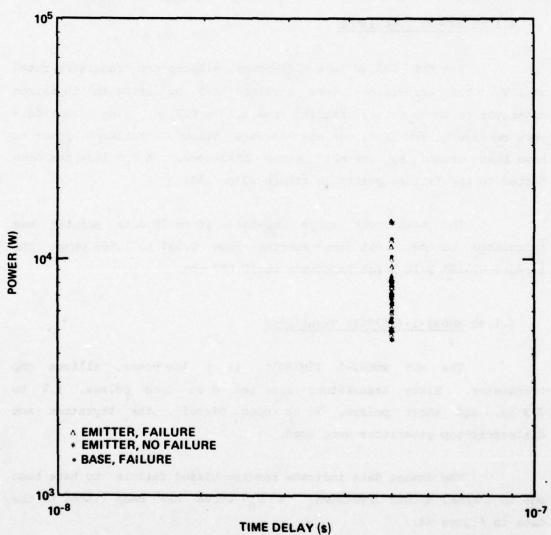
The RCA 2N3440 is a high-power, 1-W, silicon npn transistor. Eleven transistors were tested E-B with a 50-ns pulse, 39 reverse biased (E) and 10 forward biased. The data appear in figure 82. The second-breakdown transition could not be distinguished on the traces. The data show that the fail and no-fail levels are intermeshed and

Figure 82. Damage points, power, RCA 2N3440 transistor.

that the average failure level lies somewhere in the data spread.

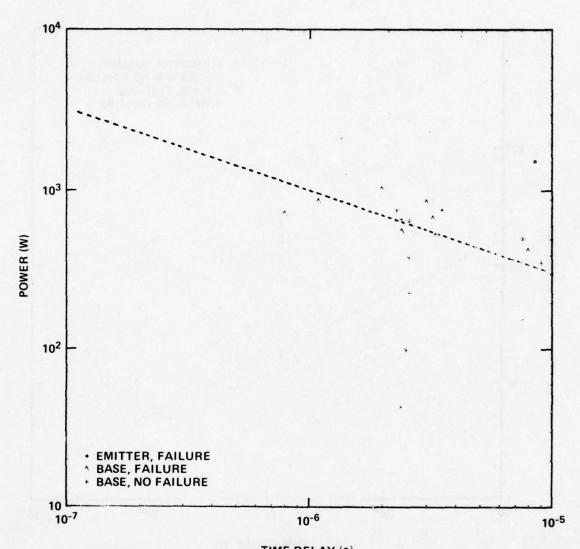
The MOT 2N3636 is a high-power, silicon pnp transistor rated at 1 W. Ten transistors were stressed E-B by using the thyratron generator to apply pulses ranging from 2.3 to 9.2 μ s. Nine transistors were reverse biased (B+); one was forward biased. Failures appear to have been caused by thermal second breakdown. A $T_D^{-\frac{1}{2}}$ line has been fitted to the failure points in figure 83(p. 133).

TIME DELAY(s)
Figure 83. Damage line, power, Motorola 2N3636 transistor.

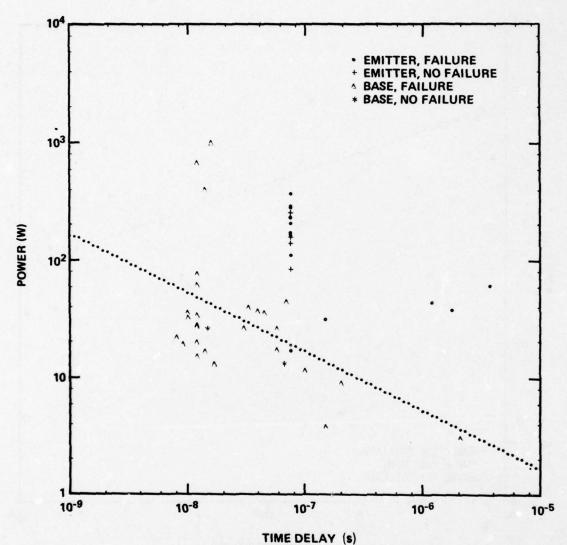
The damage data indicate reverse-biased failure to have been due to thermal second breakdown. A $T_D^{-\frac{1}{2}}$ curve has been fitted to the data in figure 84.

The average bulk surge impedance for the long pulse widths equalled ~450 ohms reverse biased and ~2.5 ohms forward biased. The distribution spread from 110 to 1200 ohms reverse biased and 1.2 to 4 ohms forward biased. For the 75-ns pulses, the bulk surge impedance was 72 ohms reverse biased and 3.2 ohms forward biased. For the 48-ns pulses, the sample size was only three and the average impedance was

Figure 84. Damage line, power, Motorola SM692-1 (2N3801) transistor.

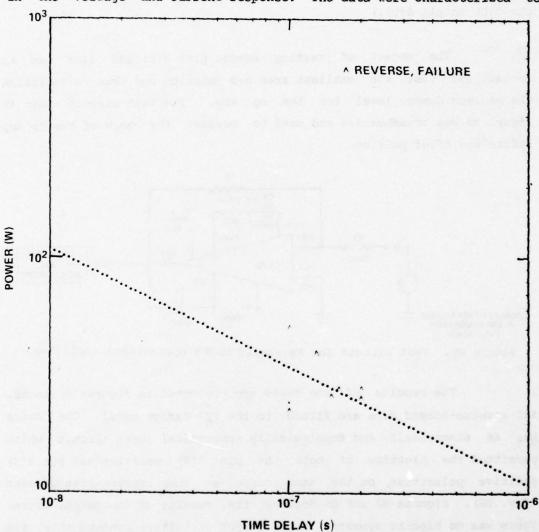
The tests on input pins 2(B) and 3(C) indicated a thermal second-breakdown failure. All op amps failed at the open-circuit voltage of 100 V or less. The output tests between pins 4(D) and 6(F) also indicate some thermal second-breakdown failure. Due to the complexity of the electrical circuit between these pins (not even considering the possible physical complexity), there were numerous steps in the voltage and current response. The data were characterized to

Figure 86. Damage line, power, Fairchild μA709 operational amplifier input pins 2(B) and 3(C).

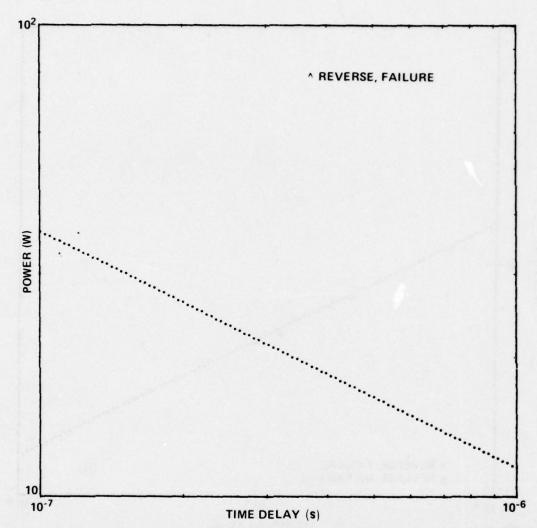
Figure 87. Damage line, power, Fairchild μA709 operational amplifier output pin 4(D).

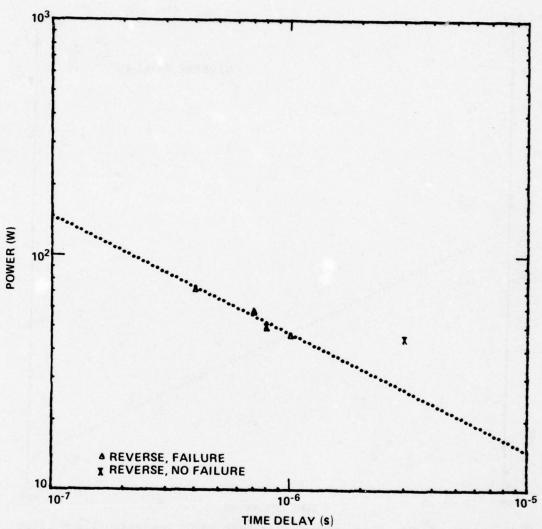
Figure 88. Damage line, power, Fairchild $\mu A709$ operational amplifier output pin 6(F).

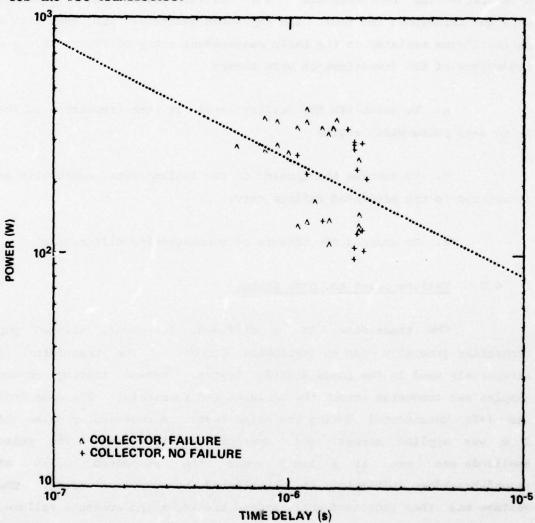
Failure has arbitrarily been defined here as a 20-percent degradation in junction breakdown voltage or device gain. Twenty-five transistors from each manufacturer were pulse tested with the polarity of the pulse generator to bias E+ with respect to C. The remaining transistors were tested with the opposite polarity. In the following graphs, the polarity is indicated by designating the device terminal connected to the positive terminal of the pulse generator. For example, in figure 89, the pin C failure and no-failure test data points are plotted for the FSC transistors.

Figure 89. Damage line, power, Fairchild 2Nll32 transistor pulse tested across collector-emitter terminals with positive pulse at collector.

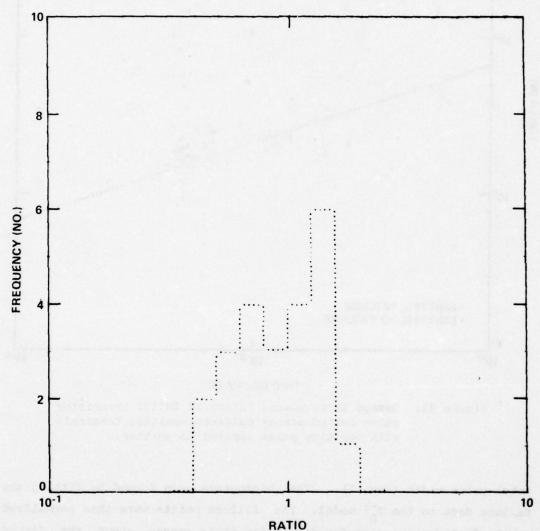
Figure 90. Spread in data points about nominal failure line for Fairchild 2Nll32 transistor; pulse polarity biased collector positive with respect to emitter.

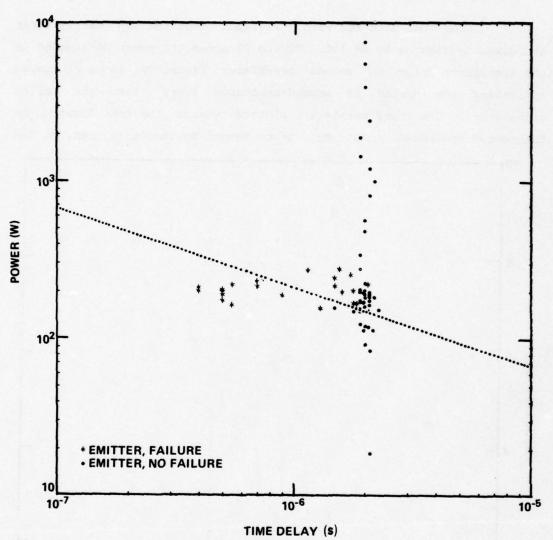
Figure 91. Damage line, power, Fairchild 2N1132 transistor pulse tested across collector-emitter terminals with positive pulse applied to emitter.

Figure 109 gives a good idea of the relative variation in size for the FSC devices. This variation could explain the larger spread about the damage line for the FSC transistors; transistor No. 71, which had the ring-dot geometry of figure 104, failed uniquely. Power levels up to 7.8 kW and current levels up to 50 A were sustained for the 2- μ s pulse E(+)-B without transistor failure. Other transistors failed at power levels of ~200 W. This transistor accounts for the train of no-failure points seen in figure 91.

The transistor eventually failed after 18 pulses of increasing power level. The voltage and current oscillogram was not obtained for this 18th pulse; consequently, a failure point for this transistor does not appear in figure 91. This high energy failure level was not consistent to the ring-dot geometry, because other failures in this geometry were at comparable levels to those of the other two geometries. There was no visual indication of why this transistor was able to sustain the high levels impressed.

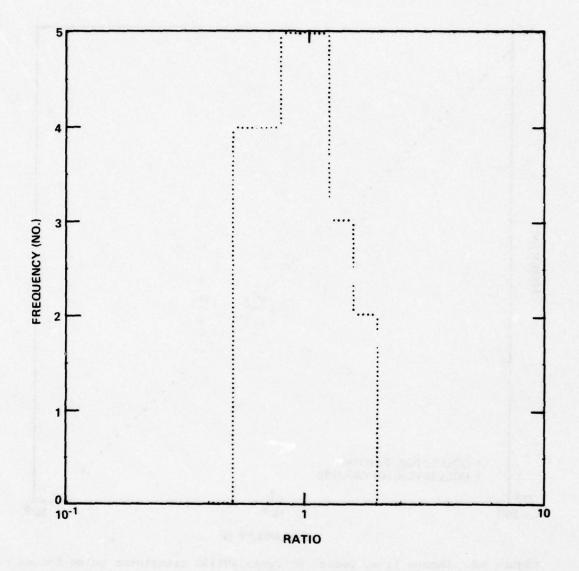
Figure 92. Spread in data points about nominal failure line for Fairchild 2Nll32 transistor; pulse polarity biased emitter positive with respect to collector.

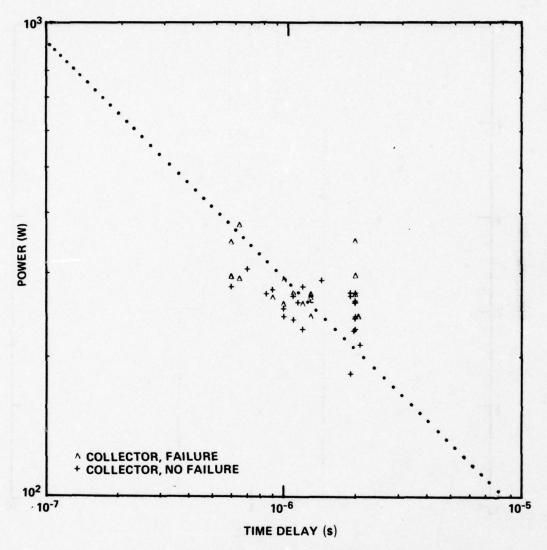
Figure 93. Damage line, power, Motorola 2N1132 transistor pulse tested across collector-emitter terminals with positive pulse applied to collector.

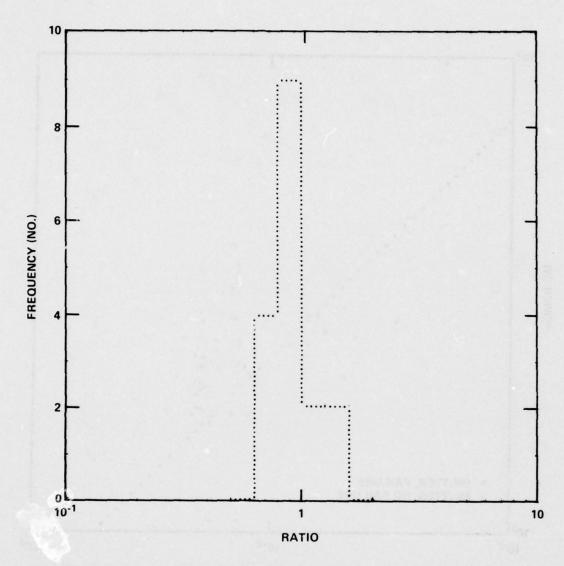
Figure 94. Spread in data points about nominal failure line for Motorola 2N1132 transistor; pulse polarity biased collector positive with respect to emitter.

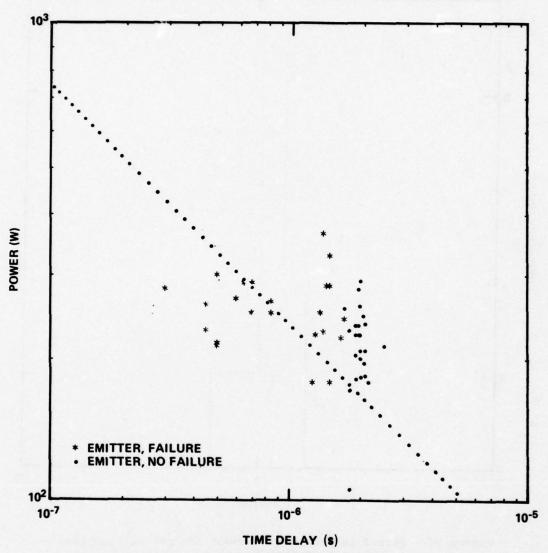
Figure 95. Damage line, power, Motorola 2N1132 transistor pulse tested across collector-emitter terminals with positive pulse applied to emitter.

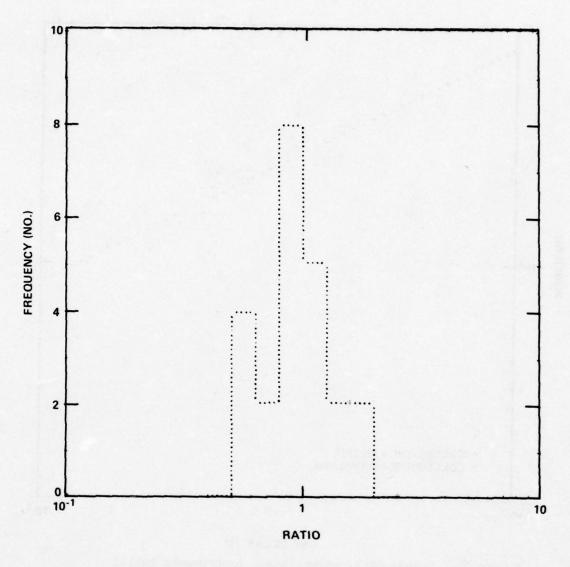
Figure 96. Spread in data points about nominal failure line for Motorola 2N1132 transistor; pulse polarity biased emitter positive with respect to collector.

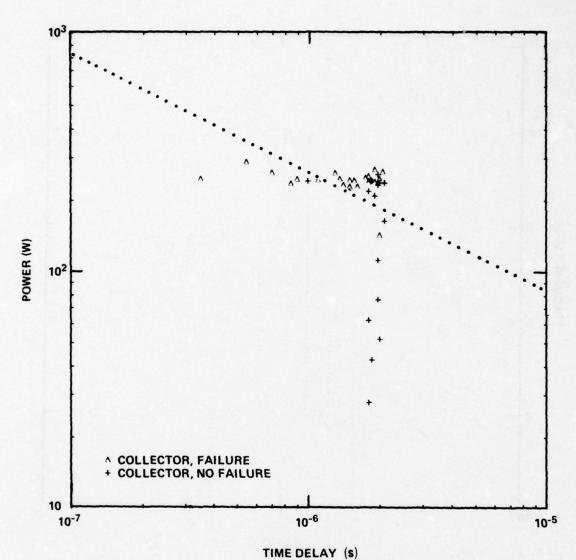
Figure 97. Damage line, power, Texas Instruments 2N1132 transistor pulse tested across collector-emitter terminals with positive pulse applied to collector.

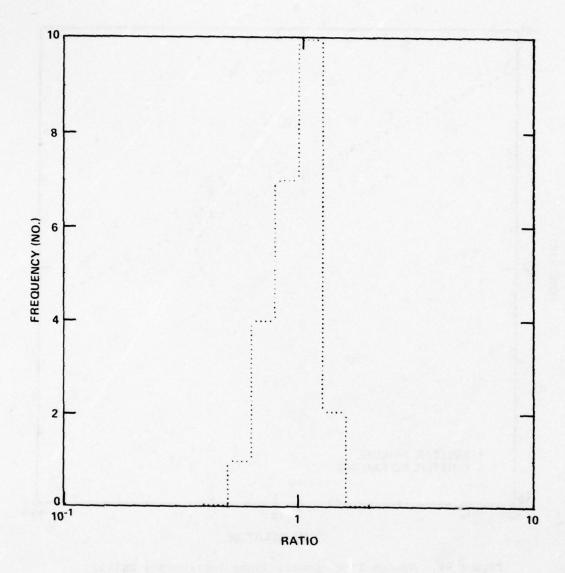
Figure 98. Spread in data points about nominal failure line for Texas Instruments 2N1132 transistor; pulse polarity biased collector positive with respect to emitter.

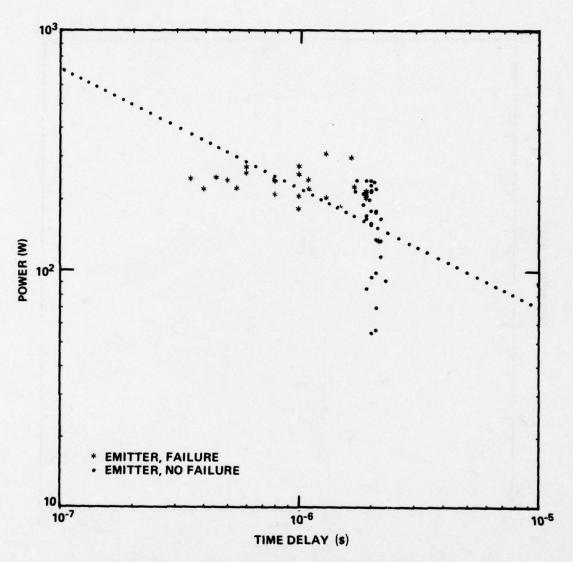
Figure 99. Damage line, power, Texas Instruments 2N1132 transistor pulse tested across collector-emitter terminals with positive pulse applied to emitter.

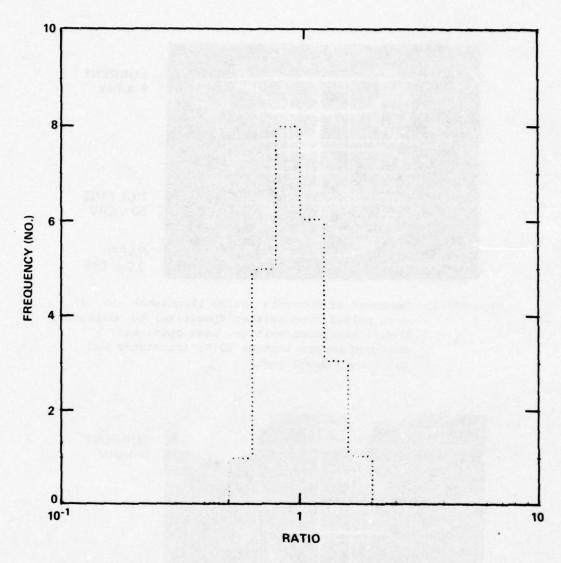
Figure 100. Spread in data points about nominal failure line for Texas Instruments 2N1132 transistor; pulse polarity biased emitter positive with respect to collector.

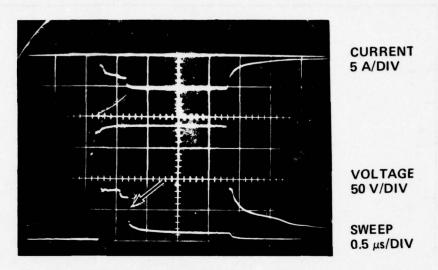
The failure response for the same pin polarity was similar for each manufacturer, but there were specific differences. Figure 101 presents the typical response of the MOT transistors pulsed E(+)-C. A

Figure 101. Response of Motorola 2N1132 transistor (No. 2) when pulsed from emitter (positive) to collector; E-C dc breakdown voltage, base open, was measured before test as 82 V; transistor was completely destroyed.

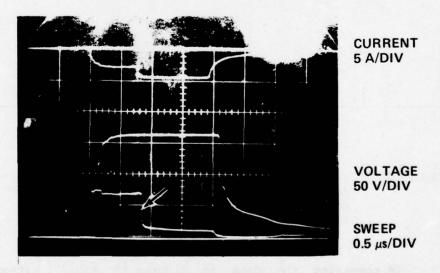
two-stage second breakdown is noted. The TI transistor's typical response showed (fig. 102) a longer delay time between the two stages of second breakdown. The FSC data (fig. 89 to 92) had examples of both

Figure 102. Response of Texas Instruments 2N1132 transistor (No. 9) when pulsed from emitter (positive) to collector; E-C dc breakdown voltage, base open, was measured before test as 73 V; transistor was completely destroyed.

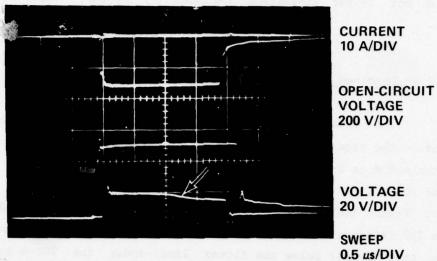
Data reduction from the C(+)-E tests was much more difficult. The typical response of the TI transistor is given in figure 103. The transition region is more prolonged than the clear-cut voltage drops of

initiation of second breakdown was chosen at the point on the voltage trace which had the greatest change in slope (arrow, fig. 103).

Figure 103. Response of Texas Instruments 2N1132 transistor (No. 48) when pulsed from collector (positive) to emitter; C-E dc breakdown voltage was measured before test as 6.2 V; transistor was completely destroyed.

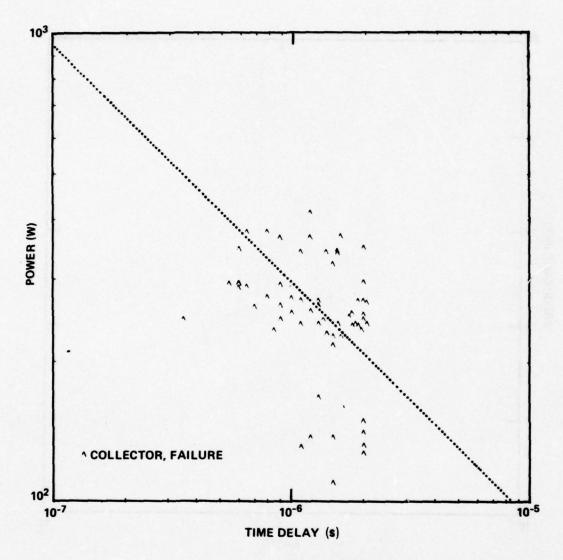
Figure 104. Damage line, power, composite data of Motorola, Texas Instruments, and Fairchild 2N1132 transistors pulse tested across collector-emitter terminals with positive pulse applied to collector.

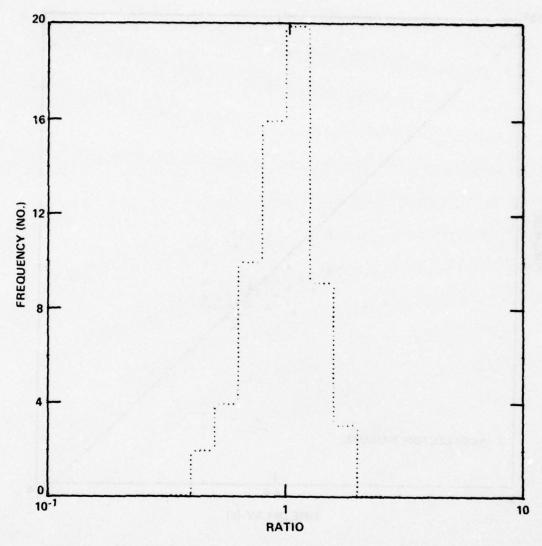
Figure 105. Spread in data points about nominal failure line for composite data of Motorola, Texas Instruments, and Fairchild 2N1132 transistors tested with collector pulse biased positive with respect to emitter; bin size factor: 0.1.

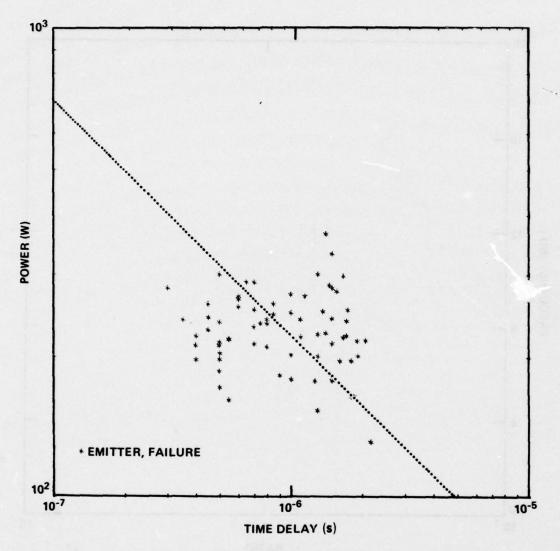
Figure 106. Damage line, power, composite data of Motorola, Texas Instruments, and Fairchild 2N1132 transistors pulse tested across collector-emitter terminals with positive pulse applied to emitter.

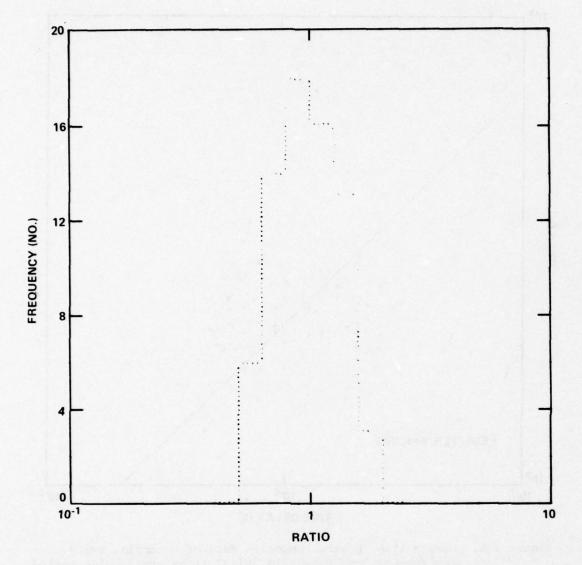
Figure 107. Spread in data points about nominal failure line for composite data of Motorola, Texas Instruments, and Fairchild 2N1132 transistors tested with emitter pulse biased positive with respect to collector; bin size factor: 0.1.

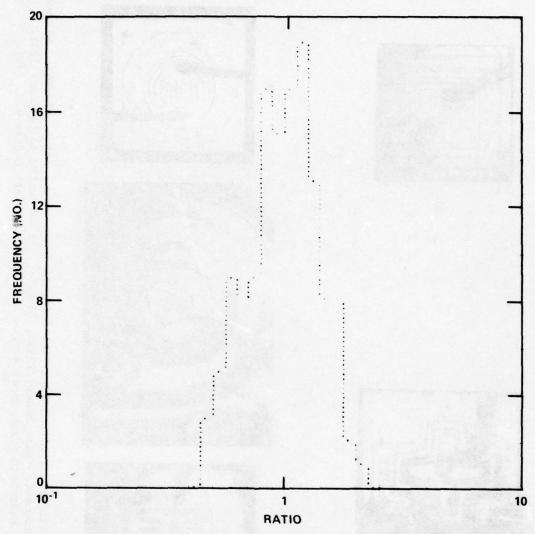
Figure 108. Spread in data points about nominal failure line for composite data of Motorola, Texas Instruments, and Fairchild 2N1132 transistors (independent of pulse polarity); bin size factor: 0.05.

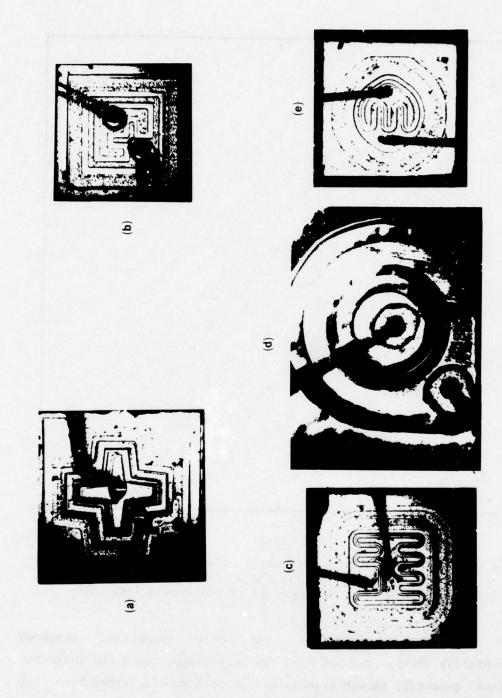
Figure 109 identifies the chip geometries observed microscopically (96X). The MOT and TI transistors each had their own consistent geometry, though transistors of both manufacturers bore two date codes. Test damage data on these transistors showed a consistent, relatively tight distribution about the established failure line. The

2N1132 transistors (96X): (a) Motorola (date codes: 6917L, 6943T); (b) Texas Instruments (date codes: 7035B, 7040B); (c) Fairchild (date code: 124); (d) Fairchild (date code: 425); (e) Fairchild (date codes: 020, 740). Figure 109.
